Draft Engineering Evaluation/Cost Analysis ROCK CREEK ABANDONED MINE SITES

**Daniel Boone National Forest
Stearns Ranger District
McCreary County, Kentucky**

January 2017

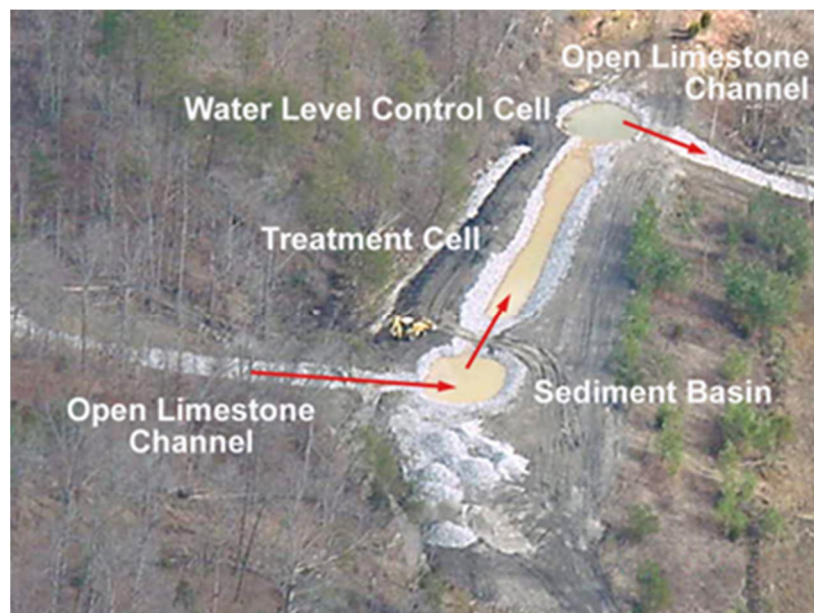
An OLC 100 feet in length intercepts the AMD before discharging into the sediment basin (see photo below). Flow proceeds from the sediment basin into the treatment cell. Water is discharged from the vertical flow system into an OLC, 100 feet in length. The water then flows across the highway and through 500 feet of low gradient limestone lined ditch before discharging into Rock Creek. A 500-foot ditch was installed along the highway that did not function as treatment due to clogging with precipitates. An additional 500 feet (152 m) of OLC was installed in a natural drain above the treatment cell. The natural drain is impacted by acidic drainage from the refuse fill. Water was diverted from the vertical flow treatment cell in June and July 2003 during construction of the additional OLC.

The pH values ranged from 2.4 to 3.9 for the 16 sampling dates that had flow prior to construction of the vertical flow system. The pH values ranged from 4.8 to 6.2 for the 17 sampling dates after installation of the vertical flow system. Acidity decreased from an average of 677 mg/L calcium carbonate (CaCO_3) to an average of 25 mg/L CaCO_3 after installation of the vertical flow system. Alkalinity increased from 0 to an average of 8 mg/L CaCO_3 after installation of the OLC. Net acidity was reduced 96% from an average of 677 mg/L CaCO_3 to an average of 26 mg/L CaCO_3 post construction. The discharge was net acidic until installation of the vertical flow system when it became net alkaline for 10 of the 17 sampling periods post construction. Net acid loading was near zero post construction with the exception of the September 25, 2001 sampling date when flow increased after a low flow period.

During the sampling period in July 2005, acidity values were 1,531 mg/L CaCO_3 equivalent entering the treatment system and 470 mg/L CaCO_3 equivalent at the discharge end of the treatment system. It was concluded that the most economical and least maintenance intensive method for additional treatment at this site was installation of a series of two self-flushing limestone ponds. This was a relatively new technology that was being used on a large scale in Pennsylvania to treat some of the worst AMD sites in that state. The technology had not been tried in Kentucky. It has several advantages over other treatment methods. Since it is self-flushing, clogging problems associated with vertical flow wetlands in waters with high aluminum concentrations such as those found at Paint Cliff are non-existent. Maintenance is far less than an active treatment system like the Aqua-fix treatment method. Limestone is used in the treatment cells instead of hydrated lime or quick lime, so pH levels remain below 8.5, eliminating concerns with vandalism or accidental releases of reagents into the environment. Additionally, the treatment cells can be sized so that maintenance is infrequent. An aerobic polishing wetland is needed prior to the discharge of the AMD into Rock Creek to settle out the iron and aluminum precipitate. Unfortunately, due to the newness of the technology and lack of knowledge regarding possible consequences, the cells installed at this site were constructed without liners. As a result, water has seeped into the hillside and emerges as seeps above and adjacent to the highway. Also, the efficacy of this system has since been reduced due to insufficient dredging of the sediments and refreshment of the limestone.
